Case Study

Superstar

Pisces and

Aquarius

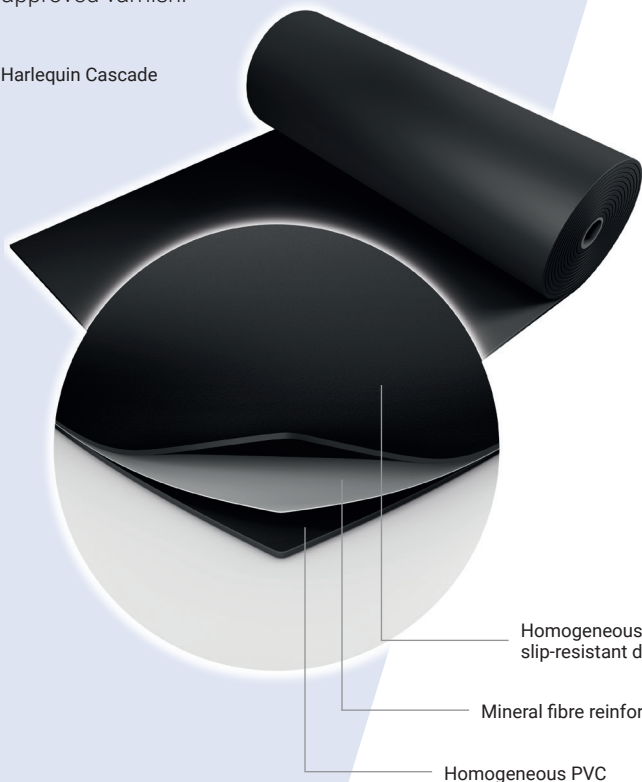
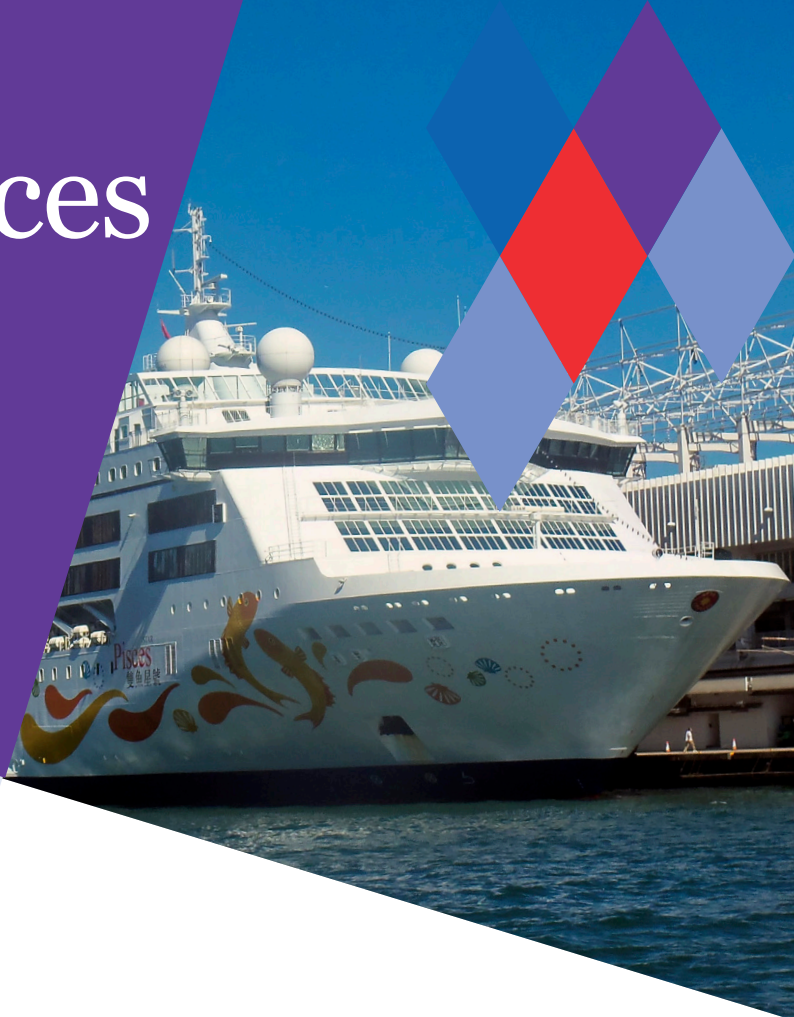
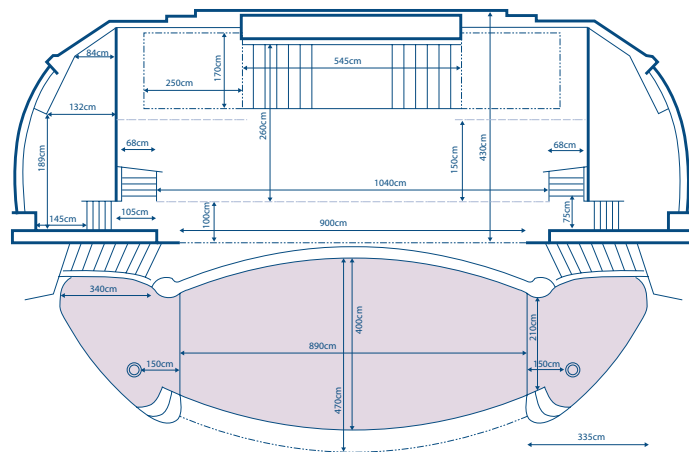
Harlequin removed the existing stages and replaced the plywood on both using two layers of Dricon® fire retardant treated 18mm timber onto Isorubber, fixed with tech screws through the plywood and Isorubber impact sound isolator.

The plywood joins were filled and sanded to a suitable finish before installing Harlequin vinyl top surfaces. Harlequin Cascade was then installed lengthways across both stages with seams welded and silicone sealant to the perimeter abutting walls.

The wooden plinths at the front of both stages were stripped of varnish, sanded and repaired then recoated with three coats of marine approved varnish.
